**Flood Control Project Maintenance
Levee Inspections****2012 Channel Summary Report****Overall Unit and Item Ratings****Adin Community Service District**

Flood Control Project Maintenance**Unit Cover Sheet****2012 Channel Inspection Results****Adin Community Service District**

**Flood Control Project Maintenance
Channel Inspections**

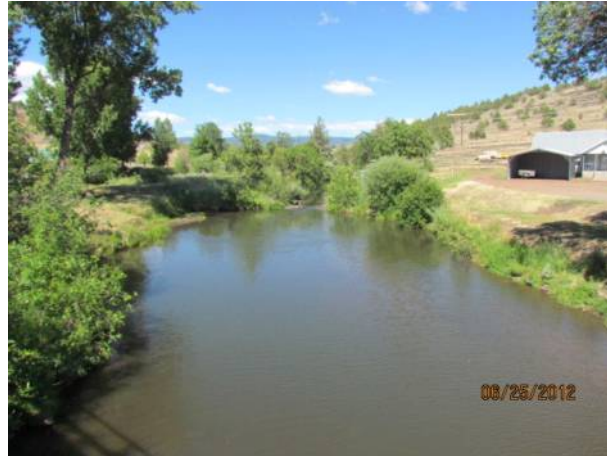
Levee Mile Report Line	1
Start Levee Mile	0.00
End Levee Mile	0.00
Location	
Category	Channels
Item	Vegetation & Obstructions

View from Main Street (Highway 299) towards the gauging station.

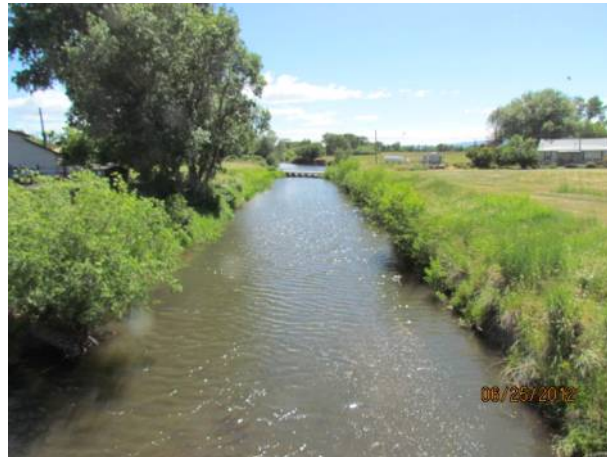
Levee Mile Report Line	6
Start Levee Mile	0.00
End Levee Mile	0.00
Location	
Category	Channels
Item	Vegetation & Obstructions

View from Main Street (Highway 299) towards the Ash St. low water crossing.

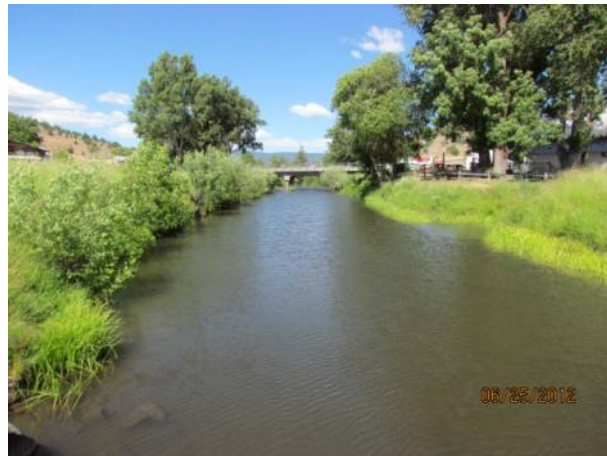
Levee Mile Report Line	11
Start Levee Mile	0.00
End Levee Mile	0.00
Location	
Category	Channels
Item	Vegetation & Obstructions

View of the channel from Ash Street low water crossing.

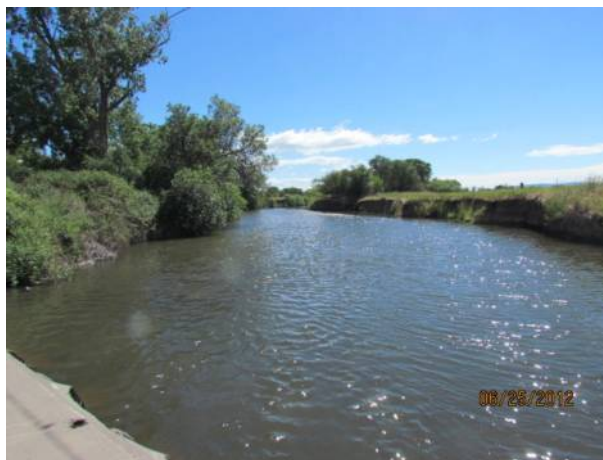
Levee Mile Report Line	18
Start Levee Mile	0.00
End Levee Mile	0.00
Location	
Category	Channels
Item	Erosion / Bank Caving

LMR No.	Check Point	View	Item	Location *	Rating **	Inspector Comment	GPS Latitude & Longitude	Photo	Issue No
18		Down	Erosion / Bank Caving		M	Inspector Comments: Monitor erosion during high flows.	41.197660 ° -120.944220 °	Y	18
19		Down	Revetments		A		41.197660 ° -120.944220 °		19
20		Down	Encroachments		A		41.197660 ° -120.944220 °		20
21	Downstream limit/fish ladder & walkway	Up	Vegetation & Obstructions		A	Inspector Comments: The channel is clear of vegetation & obstructions.	41.192990 ° -120.954530 °	Y	31
22		Up	Shoaling / Sedimentation		A		41.192990 ° -120.954530 °		32
23		Up	Erosion / Bank Caving		A	Inspector Comments: There is minor erosion along both sides of the structure.	41.192990 ° -120.954530 °		33
24		Up	Revetments		A		41.192990 ° -120.954530 °		34
25		Up	Encroachments		A		41.192990 ° -120.954530 °		35
26		Down	Vegetation & Obstructions		A	Inspector Comments: The channel is clear of vegetation & obstructions.	41.192990 ° -120.954530 °	Y	36

View of the moderate erosion on both banks.

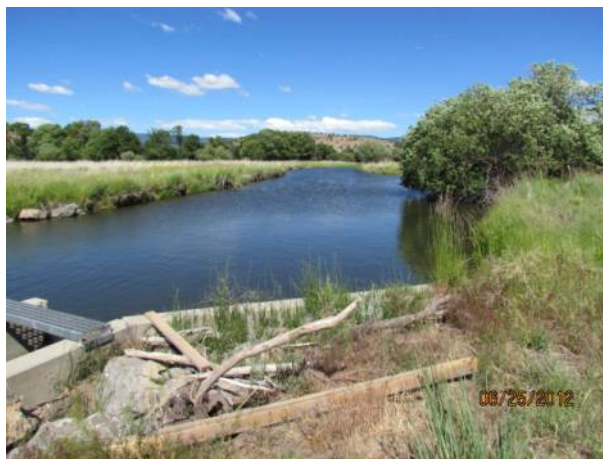
Levee Mile Report Line	21
Start Levee Mile	0.00
End Levee Mile	0.00
Location	
Category	Channels
Item	Vegetation & Obstructions

View of the upstream side of the weir.

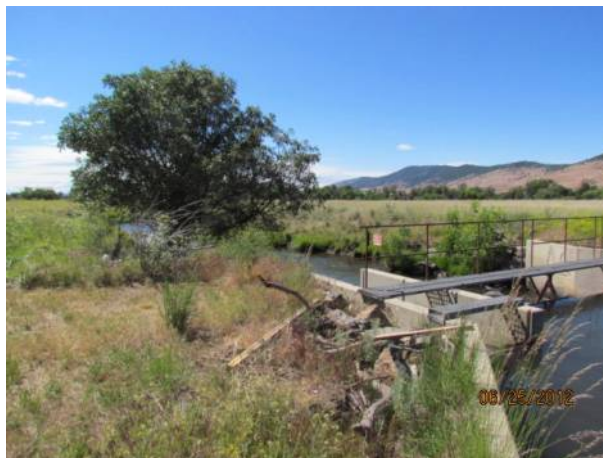
Levee Mile Report Line	26
Start Levee Mile	0.00
End Levee Mile	0.00
Location	
Category	Channels
Item	Vegetation & Obstructions

View of the downstream side of the dam & fish ladder constructed by Dept. of Fish & Game in October 1999.

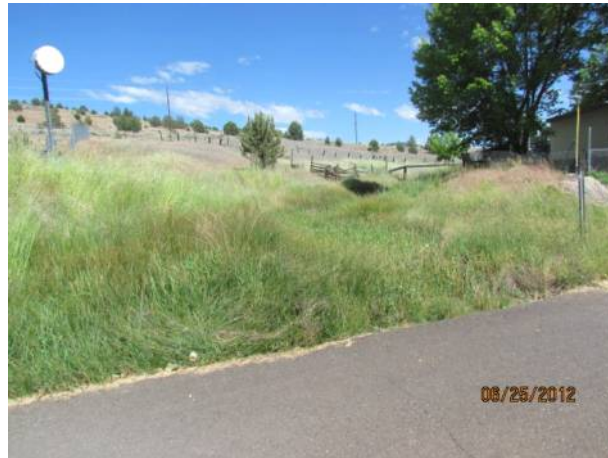
Levee Mile Report Line	1
Start Levee Mile	0.00
End Levee Mile	0.00
Location	
Category	Channels
Item	Vegetation & Obstructions
Upstream at Adin Street. Minimal growth in channel.	
rduffey_c_20120710_027.jpg

LMR No.	Check Point	View	Item	Location	Rating	Inspector Comment	GPS Latitude & Longitude	Photo	Issue No
1	Adin Street	Up	Vegetation & Obstructions		A	Inspector Comments: Remove all vegetation in channel before winter.	41.195370 ° -120.943190 °	Y	1
2		Up	Shoaling / Sedimentation		A		41.195370 ° -120.943190 °		2
3		Up	Revetments		A		41.195370 ° -120.943190 °		4
4		Up	Encroachments		A		41.195370 ° -120.943190 °		5
5		Down	Vegetation & Obstructions		A	Inspector Comments: Remove all vegetation in channel before winter.	41.195370 ° -120.943190 °	Y	6
6		Down	Shoaling / Sedimentation		A		41.195370 ° -120.943190 °		7
7		Down	Erosion / Bank Caving		A		41.195370 ° -120.943190 °		3
8		Down	Erosion / Bank Caving		A		41.195370 ° -120.943190 °		8
9		Down	Revetments		A		41.195370 ° -120.943190 °		9
10		Down	Encroachments		A		41.195370 ° -120.943190 °		10
11	Main Street	Up	Vegetation & Obstructions		A	Inspector Comments: Remove all vegetation in channel before winter.	41.196350 ° -120.944250 °	Y	11

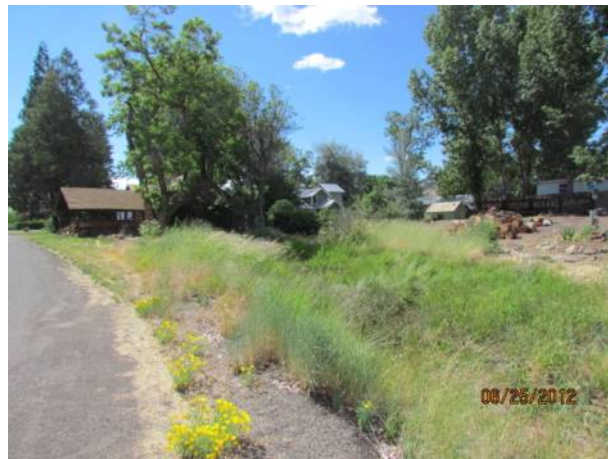
Levee Mile Report Line	5
Start Levee Mile	0.00
End Levee Mile	0.00
Location	
Category	Channels
Item	Vegetation & Obstructions
Downstream from Adin Street. Minimal growth in channel.	
rduffey_c_20120710_028.jpg

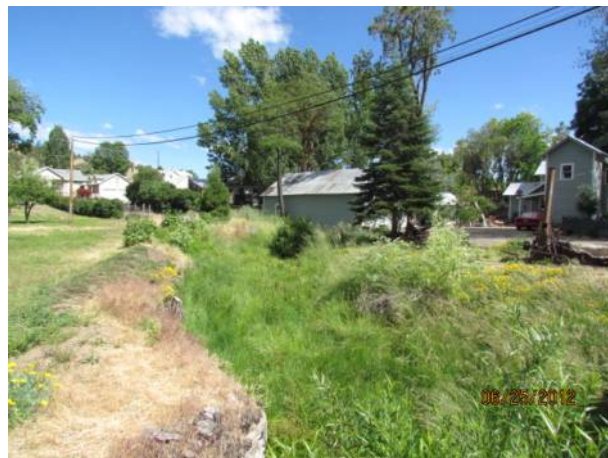
Levee Mile Report Line	11
Start Levee Mile	0.00
End Levee Mile	0.00
Location	
Category	Channels
Item	Vegetation & Obstructions
Upstream from Main Street. Minimal growth in channel.	
rduffey_c_20120710_029.jpg

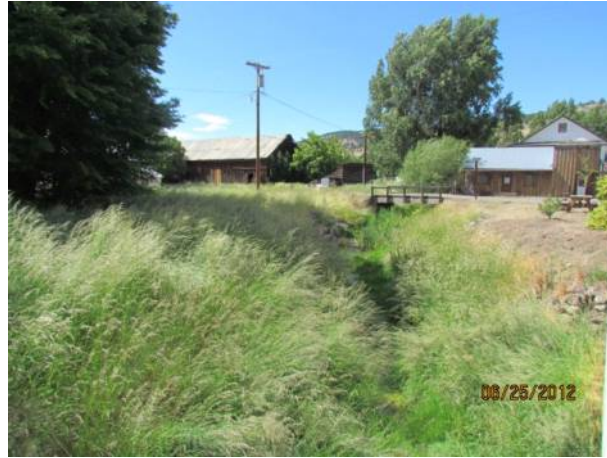
Levee Mile Report Line	16
Start Levee Mile	0.00
End Levee Mile	0.00
Location	
Category	Channels
Item	Vegetation & Obstructions

View of the minimal vegetation in channel.

12		Up	Shoaling / Sedimentation		A		41.196350 ° -120.944250 °		12
13		Up	Erosion / Bank Caving		A		41.196350 ° -120.944250 °		13
14		Up	Revetments		A		41.196350 ° -120.944250 °		14
15		Up	Encroachments		A		41.196350 ° -120.944250 °		15
16		Down	Vegetation & Obstructions		A	Inspector Comments: Remove all vegetation from channel before winter.	41.196350 ° -120.944250 °	Y	16
